# EGR Blanking Module 005 Installation Guide

**Mazda BT50 2.5L/3.0L 2006 - 2011**

**Ford Ranger PJ 2.5L/3.0L 2006 - 2011**

**Ford Ranger PK 2.5L/3.0L 2006 - 2011**

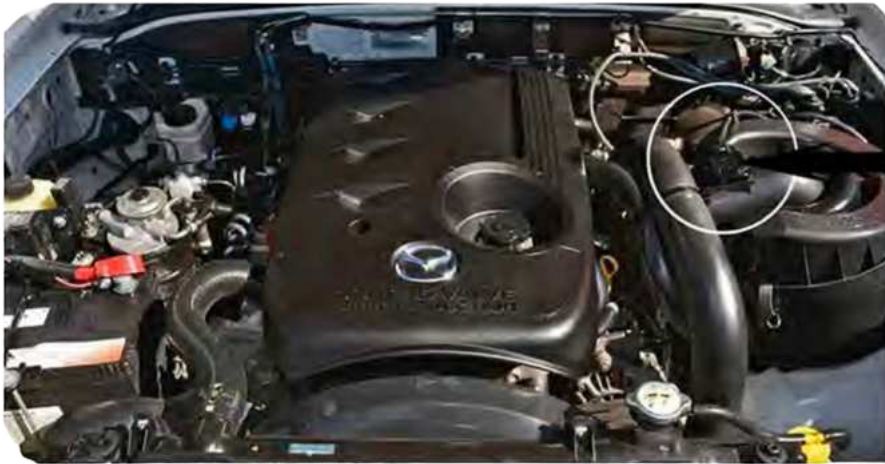
Find the sensor as shown in the following picture

**This is the sensor  
you need to look for  
on the air box**

Disconnect the plug from the sensor and add the module in between. You won't get it wrong since the two connectors from the module can only fit in the correct way.
